## Meeting Minutes

**Job:** 14-24 Howard Elementary School  
**Location:** 700 Howard Ave  
Eugene, OR 97404

**Meeting:** Owner/Architect/GC # 50  
**Date:** 11/25/15  
**Start Time:** 9:00:00AM

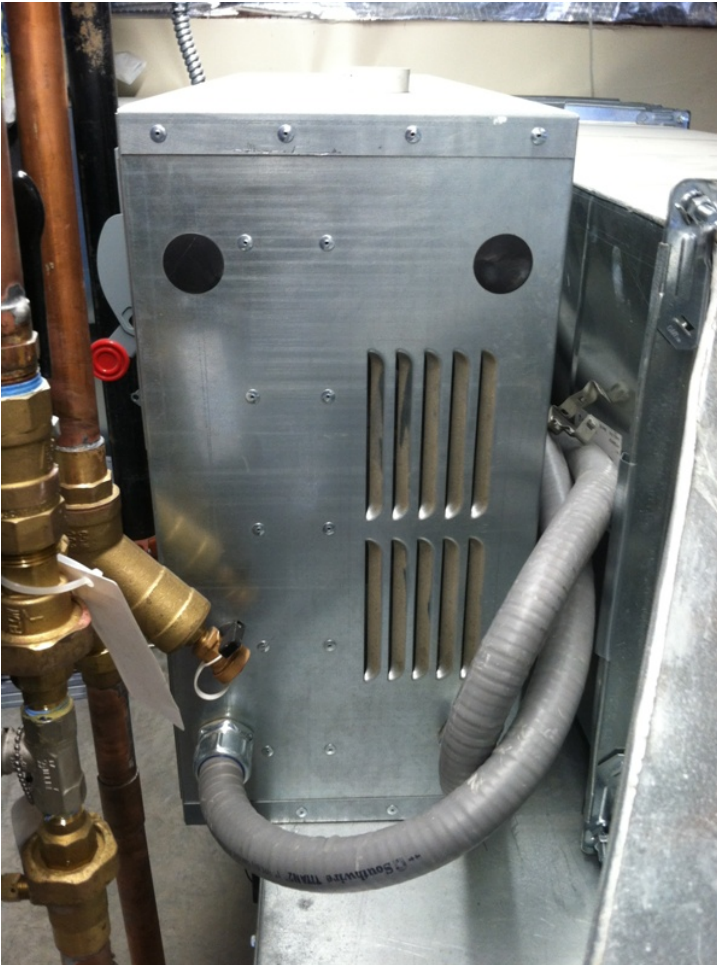
#### 15-014 Supporting Image: AH-C106 strainer

### 15-014: Strainer blow-down location

AH-C106 had the strainer blow down located very close to vents in control cabinet. This is a potential shock hazard in the event that water makes its way through the box vent. It appears to be difficult to connect a hose to this blow down. We recommend rotating the strainer such that the blow-down points away from the control cabinet. Please ensure the manual valve remains operable. It may be necessary to move the control cabinet slightly.

System: AH-C106

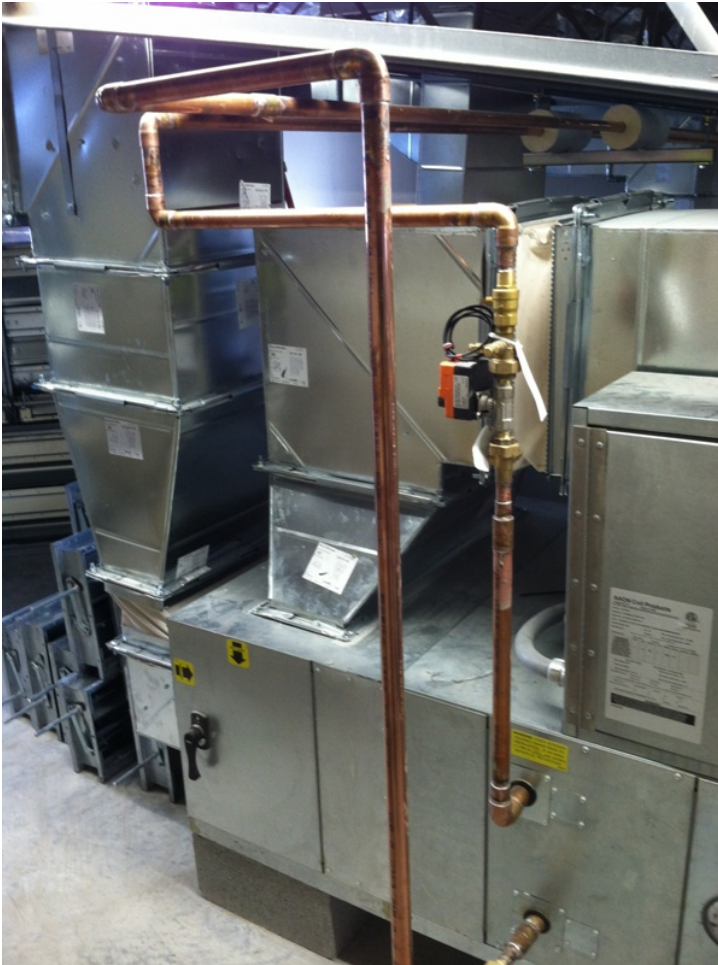
15-015 Supporting Image: **Unstable piping**

### 15-015: Pipe supports/bracing

Verify that the distance between the piping mounting points are within spec (max horizontal span of 5 feet). Several units had very unstable connections and were not very secure. Too much flexibility may damage the piping coil connections. Verify seismic bracing as well. Add supports and/or bracing as needed.

System: Classroom AHUs
